KENTUCKY HISTORIC RESOURCES
INDIVIDUAL SURVEY FORM
(KHC 2002-1)

1. NAME OF RESOURCE (how determined):
Julius Marks Sanitorium

2. ADDRESS/LOCATION:
corner of Keller Ct and Georgetown Road, Lexington, KY 40511

KENTUCKY HISTORIC RESOURCES INVENTORY

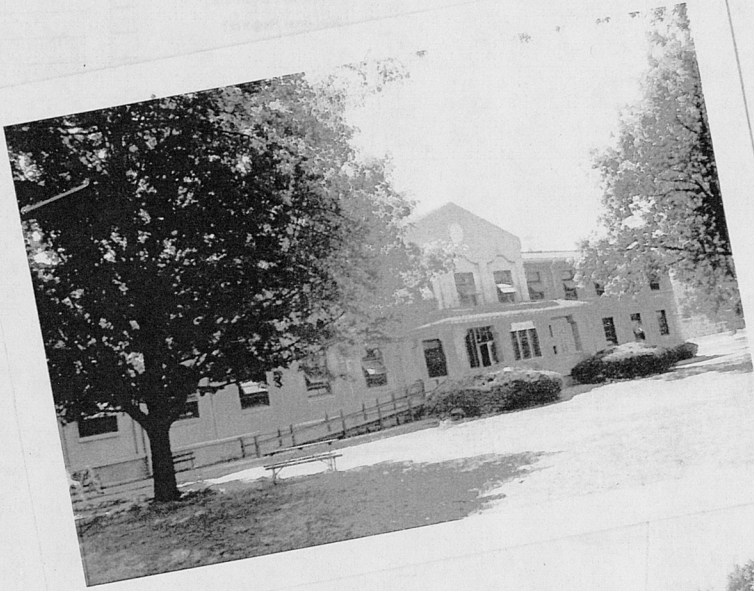
The building south of the main building is 2 story with multiple bays with a 3 bay center mass that projects slightly forward and has a 1 story porch. Recessed arches rising from slim pilasters frame windows. Center bay has more elaborate arch treatment and a pediment above with medallion-like circle set in it. Roof is tile. An underground walkway connects this building to the main building, according to the Sanborn map. This building was constructed in 1939. (photo 2)

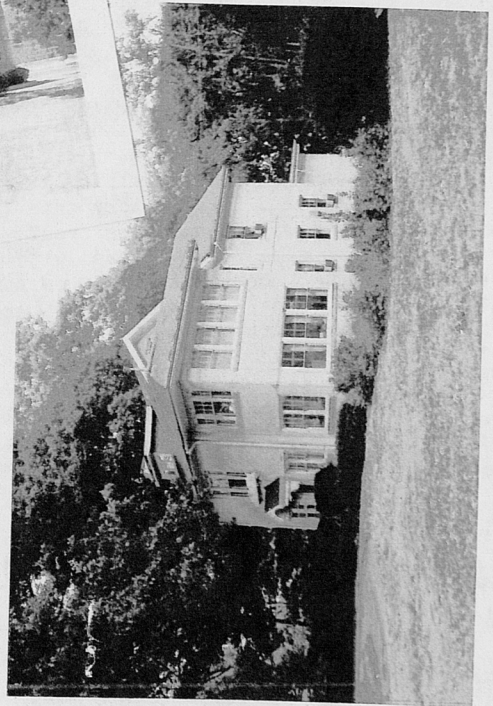
Other buildings include a one story, 4 bay, square building with tile roof. Doorway frame projects forward and has recessed entry. It is articulated with semi-circle motif running around it (photo 3). A 2 story, 3 bay building with high foundation has gable roof with projecting dormers. Pediment overhang with large brackets over entrance bay. Triple windows in first floor and a triple window in center bay of 2nd floor (photo 4). Another $2\frac{1}{2}$ story gable roof building used as a child care center has a 1 story porch over entrance bay. Porch has raised parapet above cornice. Shed roof dormer projects from roof (photo 5). The house on the northern end of the complex was used as the residence for the superintendant. It is $2\frac{1}{2}$ story, 3 bay with gable roof. Pedimented overhang supported by "chunky" brackets over entrance (photo 6). There are several more modern buildings in the complex as well.
